North West Harbour Grain Silo Inspection Report

Date: 2020-10-01 Reviewed
By: Frank Robertson

APC Integrity
40 Main St, Toronto, Ontario

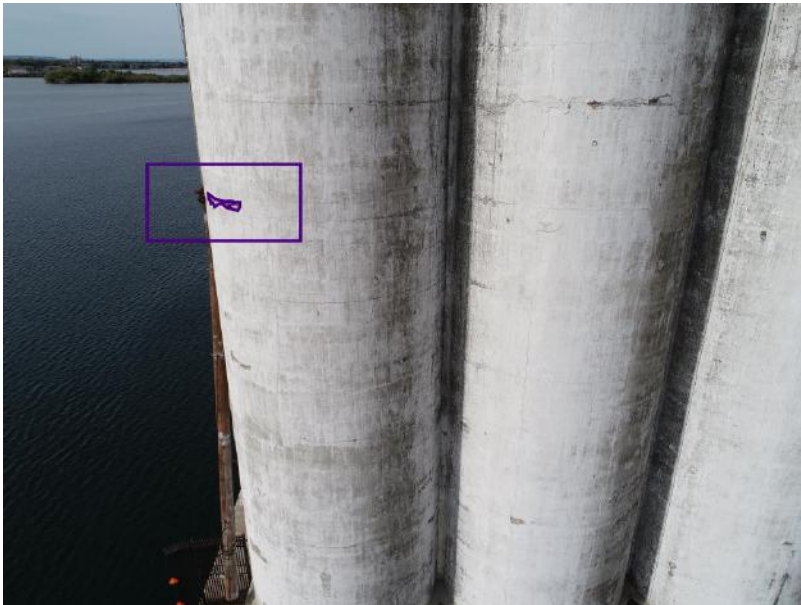
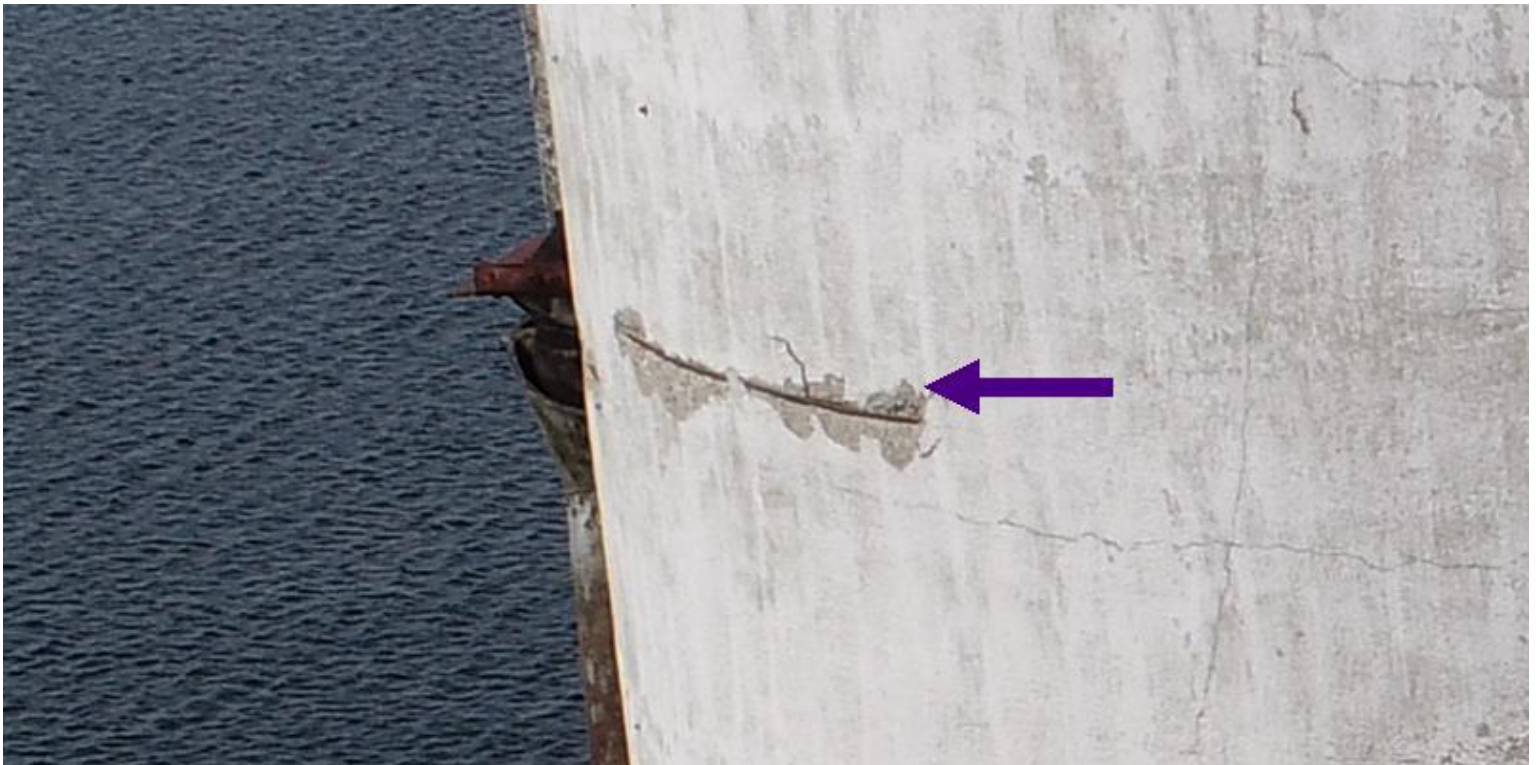
Anomaly No. 1

Type	Spalling
Latitude	44.510176
Longitude	-80.222907
Image	DJI_0074.JPG
Area (sq. m)	0.007324
Status	Request for repair

It is our opinion that the observed concrete deterioration is not structurally significant but should be repaired while other concrete restoration work is being undertaken at the facility.

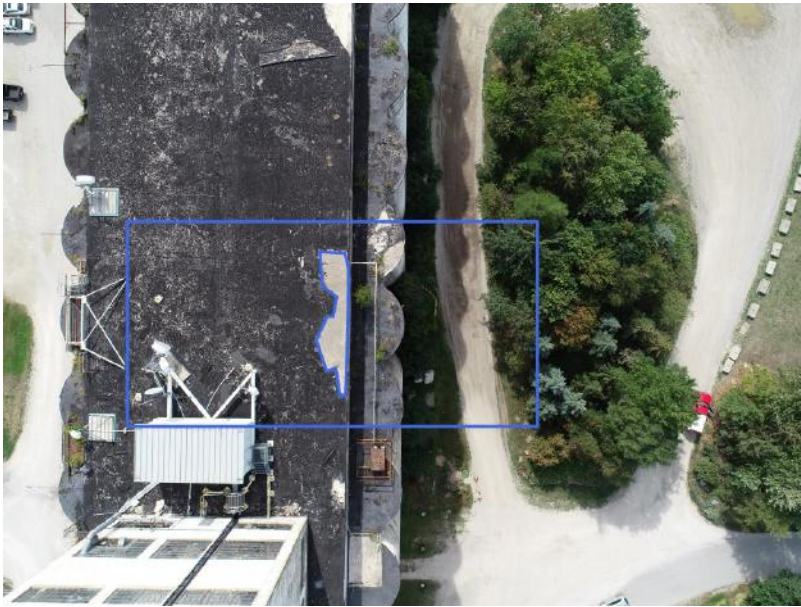
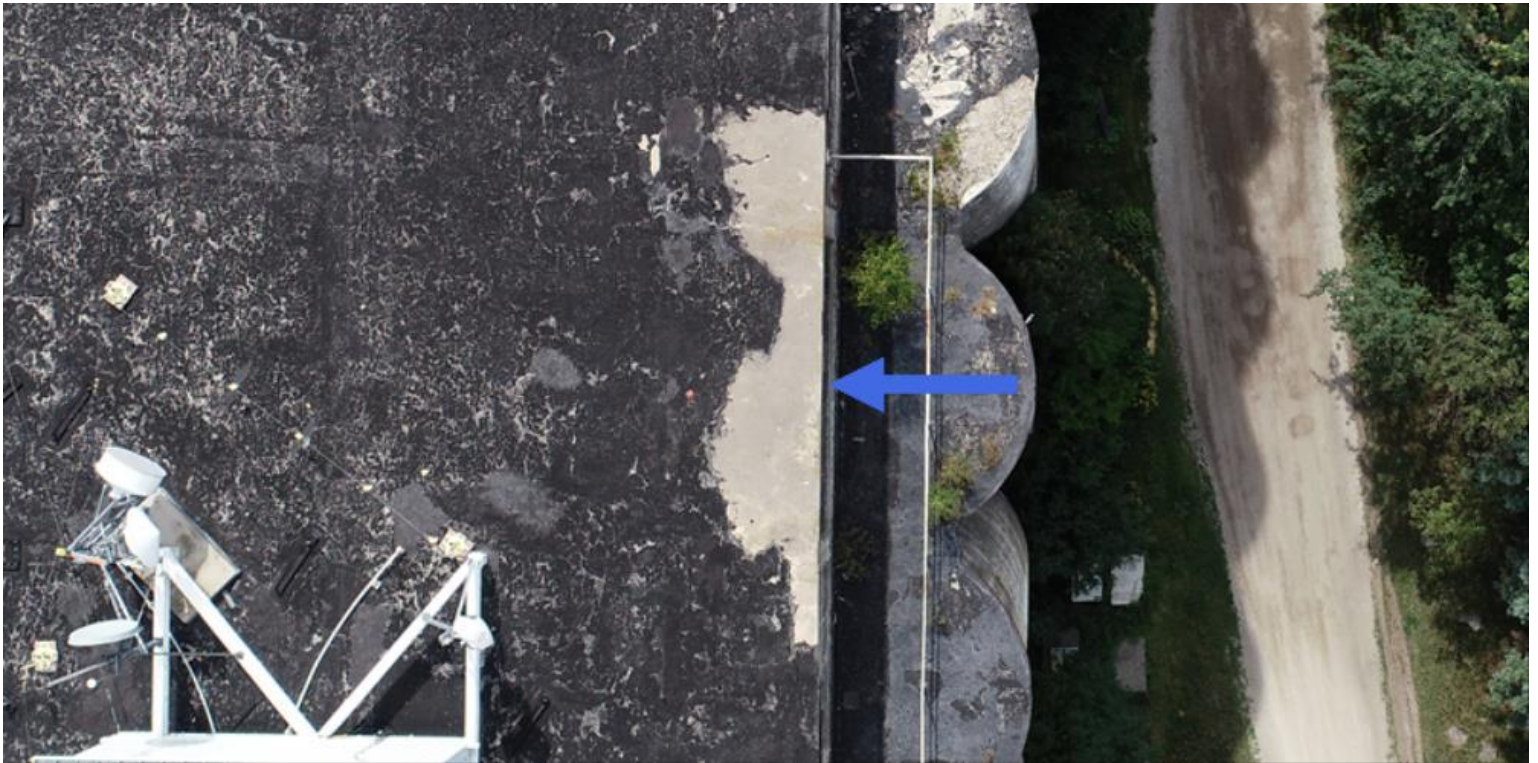
Anomaly No. 2

Type	Flaking
Latitude	44.510746
Longitude	-80.222495
Image	DJI_0875.JPG
Area (sq. m)	16.704346
Status	Request for repair

The failure of the roof membrane is allowing considerable leakage into the structure. This leakage is resulting in accelerated deterioration of the concrete structure and if not mitigated could lead to premature failure including the bin top slabs.

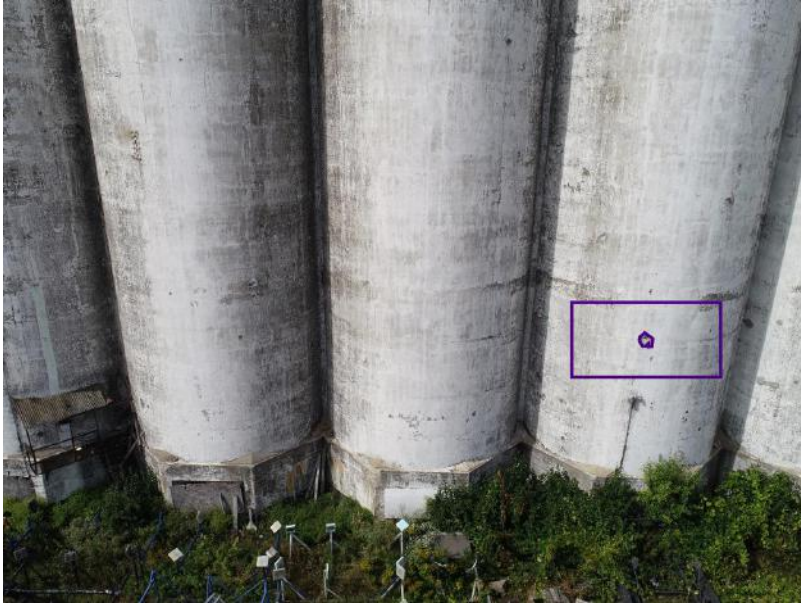
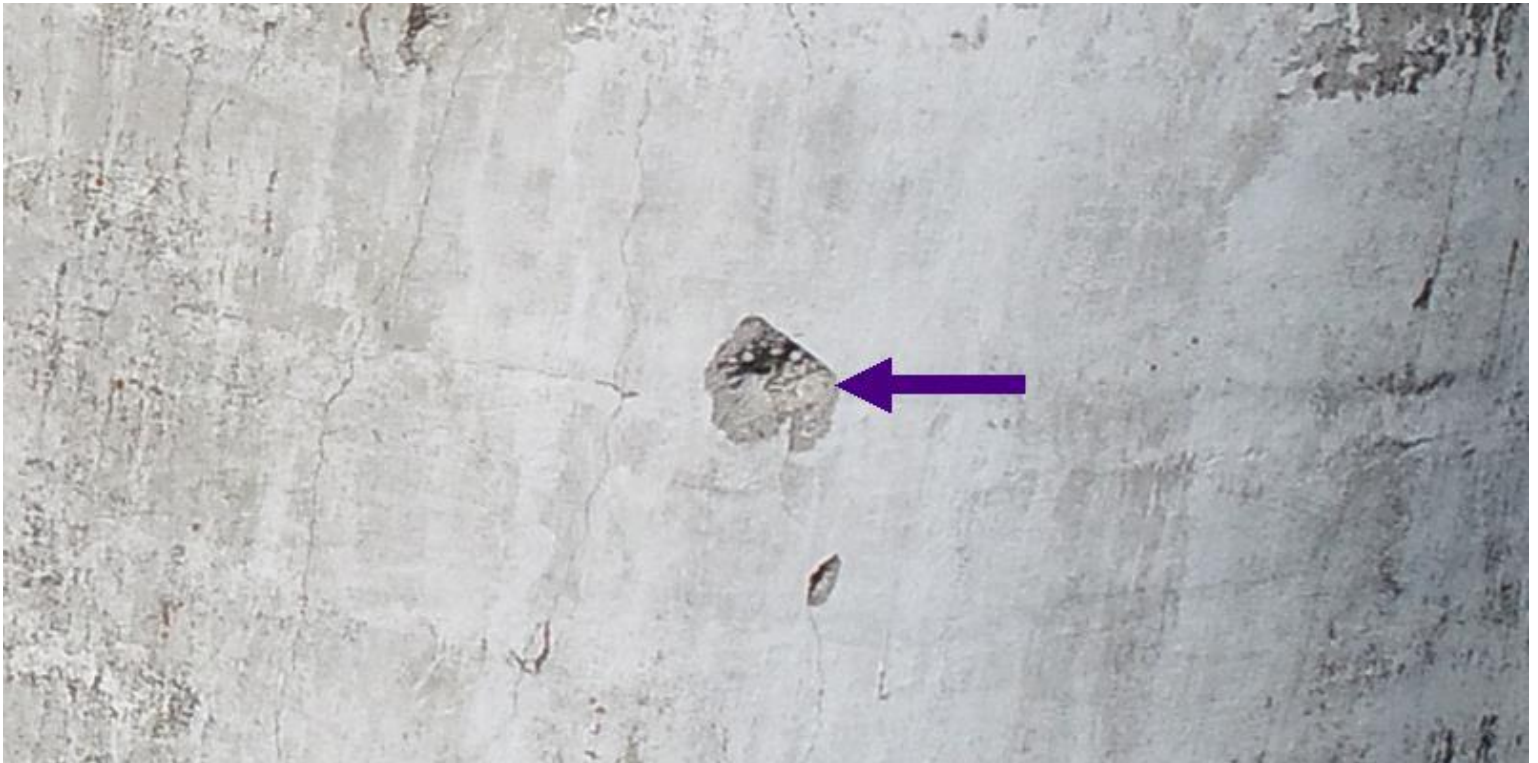
Anomaly No. 3

Type	Spalling
Latitude	44.510555
Longitude	-80.222358
Image	DJI_0029.JPG
Area (sq. m)	0.072754
Status	Request for repair

It is our opinion that the observed concrete deterioration is not structurally significant but should be repaired while other concrete restoration work is being undertaken at the facility.

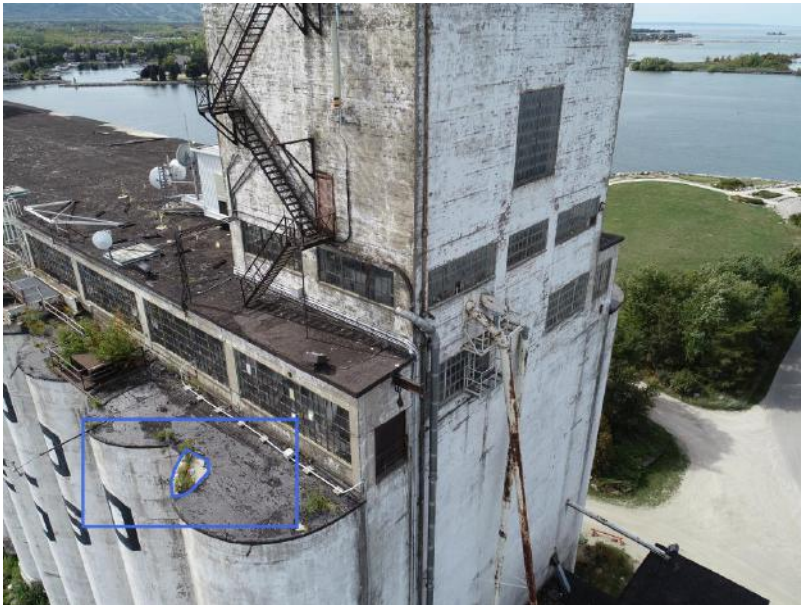
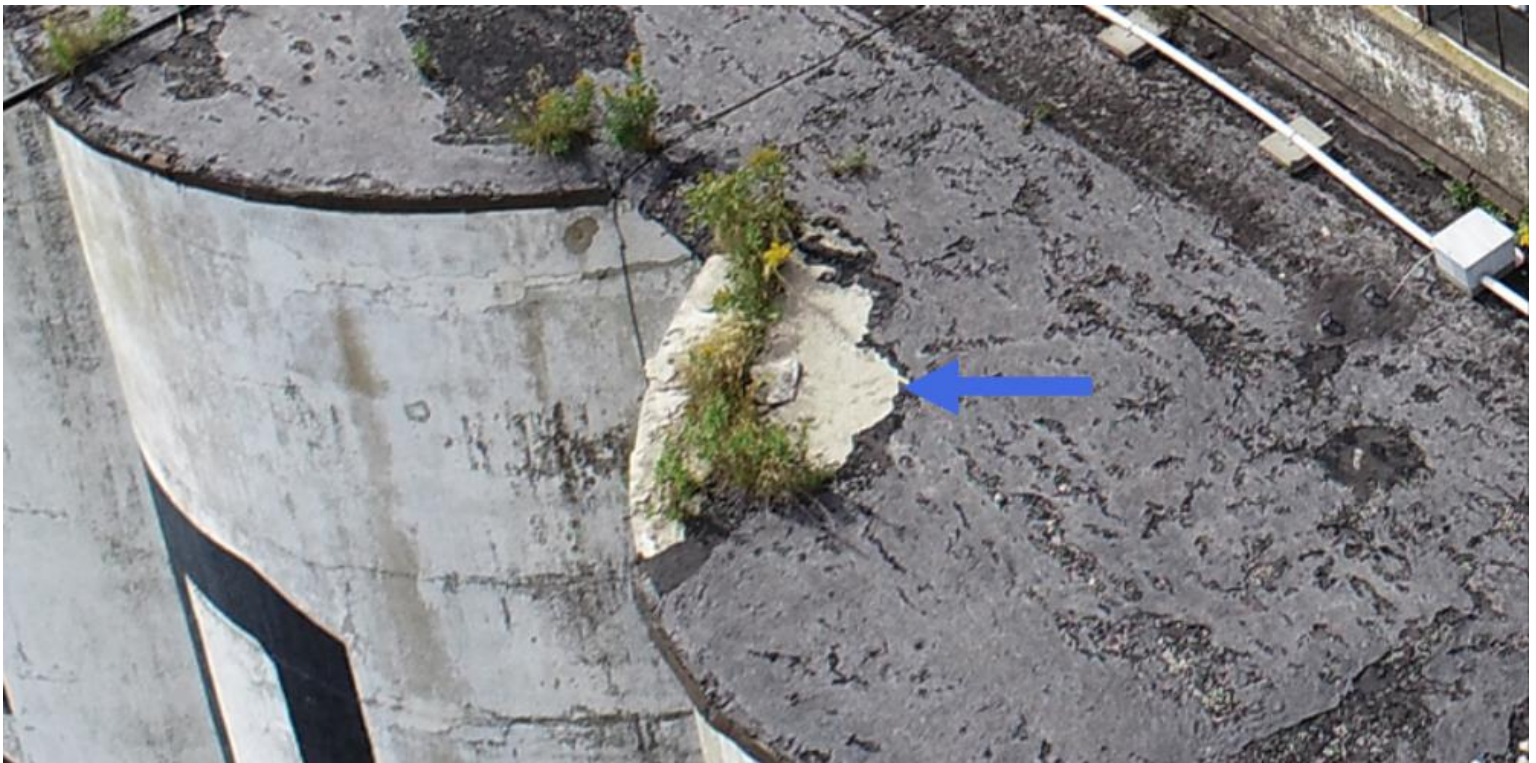
Anomaly No. 4

Type	Flaking
Latitude	44.510731
Longitude	-80.222107
Image	DJI_0714.JPG
Area (sq. m)	1.698486
Status	Request for repair

The failure of the roof membrane is allowing considerable leakage into the structure. This leakage is resulting in accelerated deterioration of the concrete structure and if not mitigated could lead to premature failure including the bin top slabs. Replacement of the roof system is required.

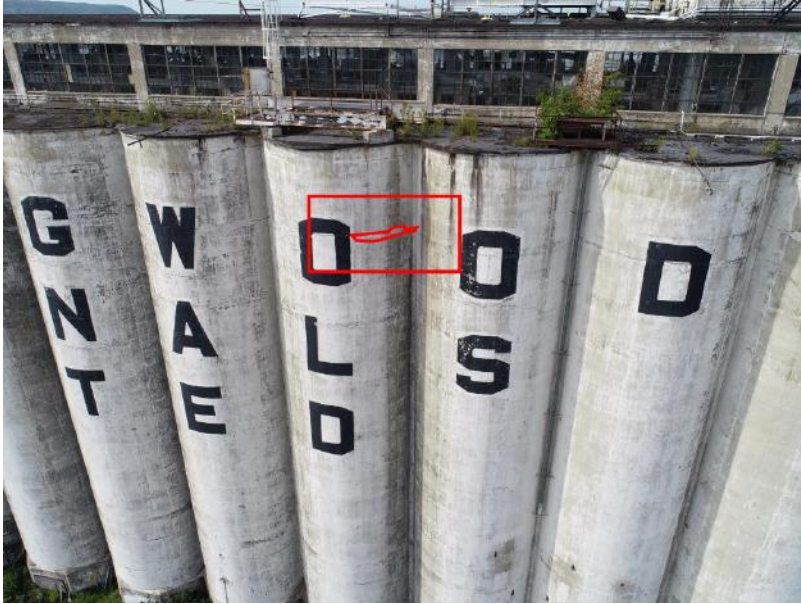
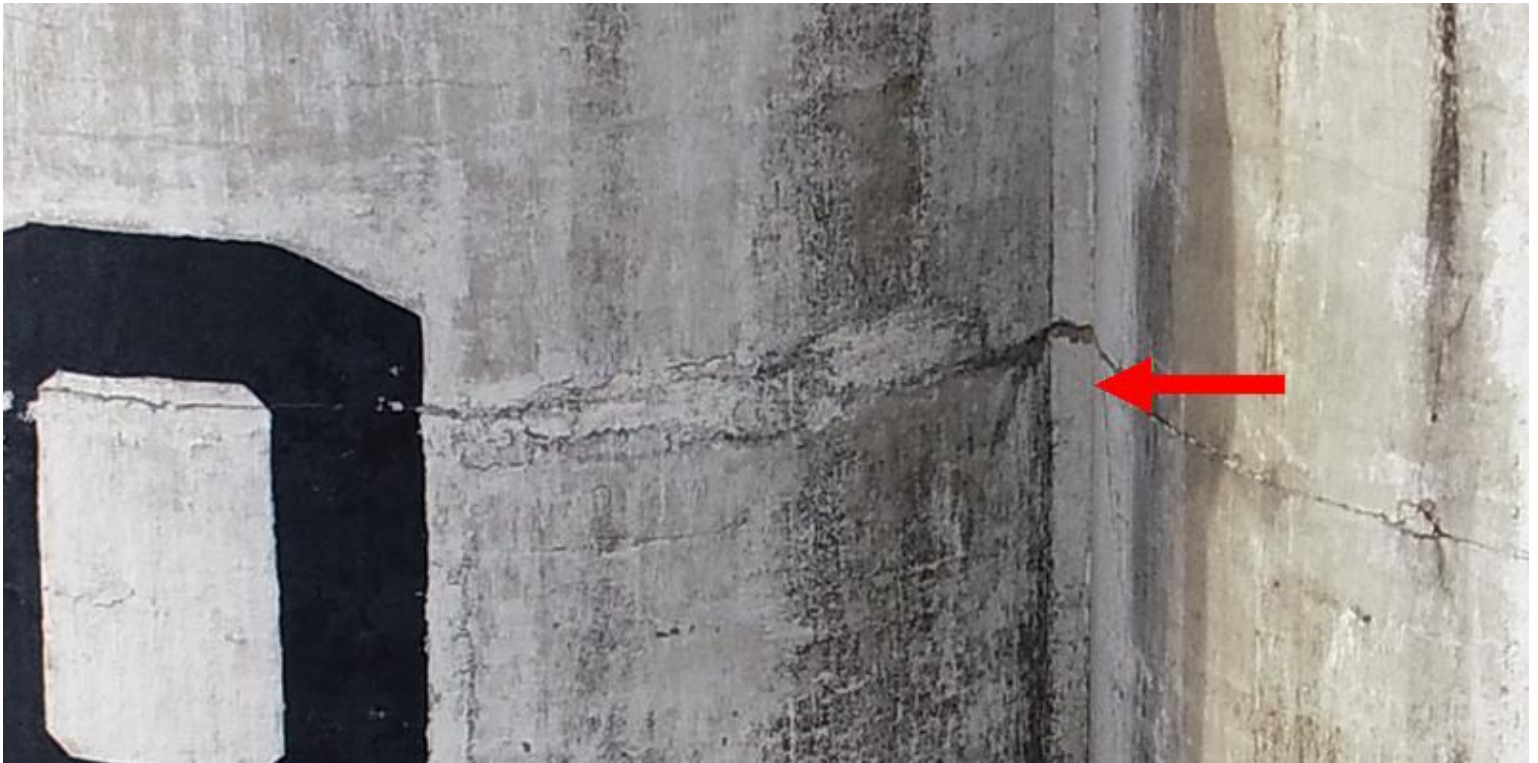
Anomaly No. 5

Type	Hairline Crack
Latitude	44.510624
Longitude	-80.222266
Image	DJI_0676.JPG
Area (sq. m)	0.908447
Status	Request for repair

While the existing coating (paint) may have been installed only as a decorative finish, we conclude that that the concrete structure would benefit considerably by the application of a new coating that would both return an aesthetically acceptable finish and provide longterm protection to the concrete.

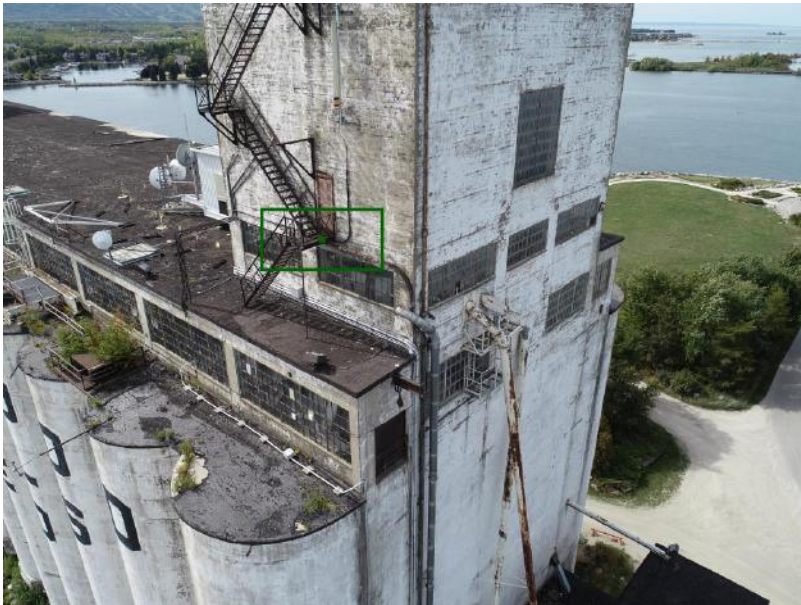
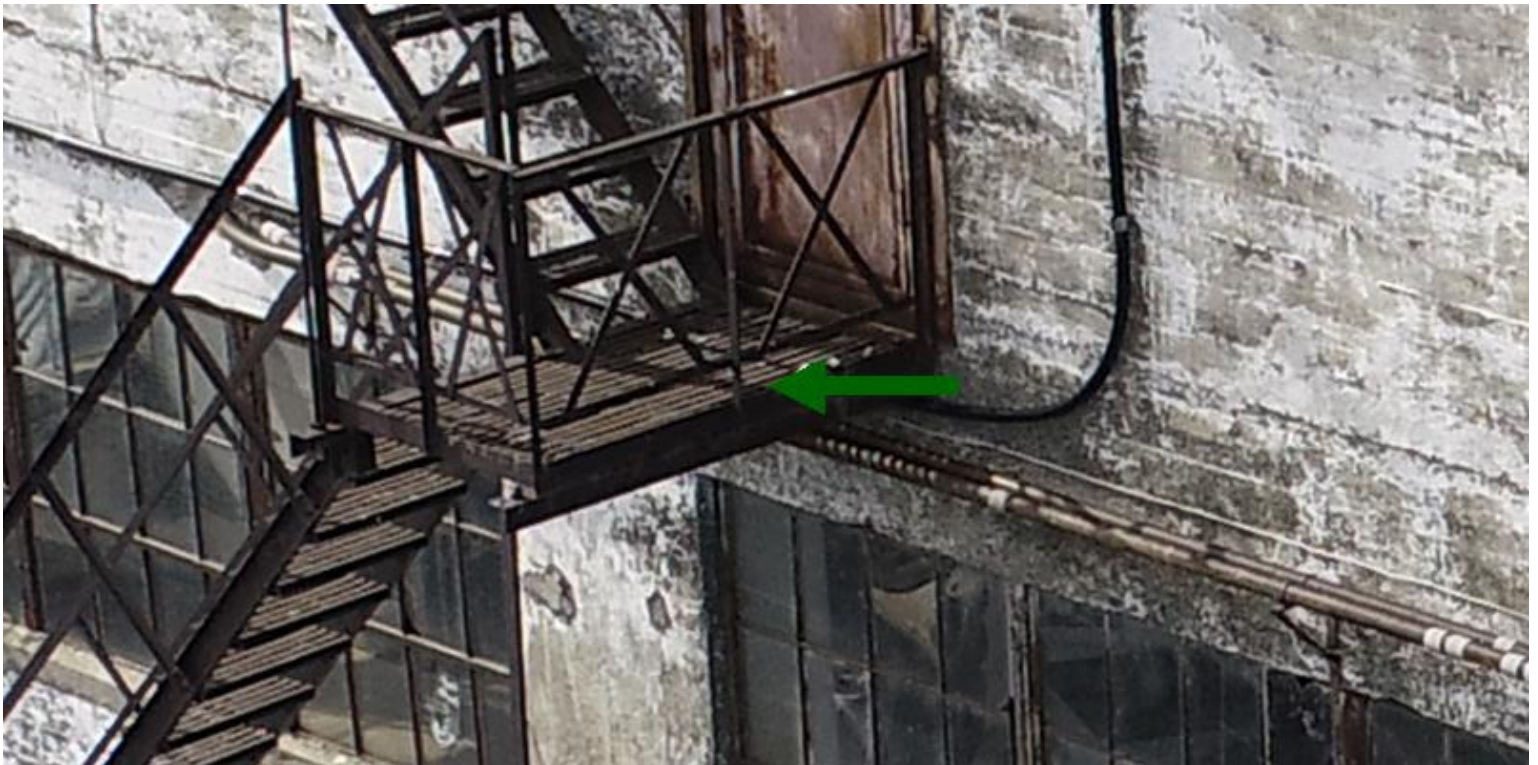
Anomaly No. 6

Type	Corrosion
Latitude	44.510776
Longitude	-80.222136
Image	DJI_0714.JPG
Measurement	NA
Status	Request for repair

Ladders are not safe for continued use. The observed deteriorated to the access ladder from Switchgear Room to Substation Mezzanine was the result of active water infiltration and must be addressed as part of any remediation.

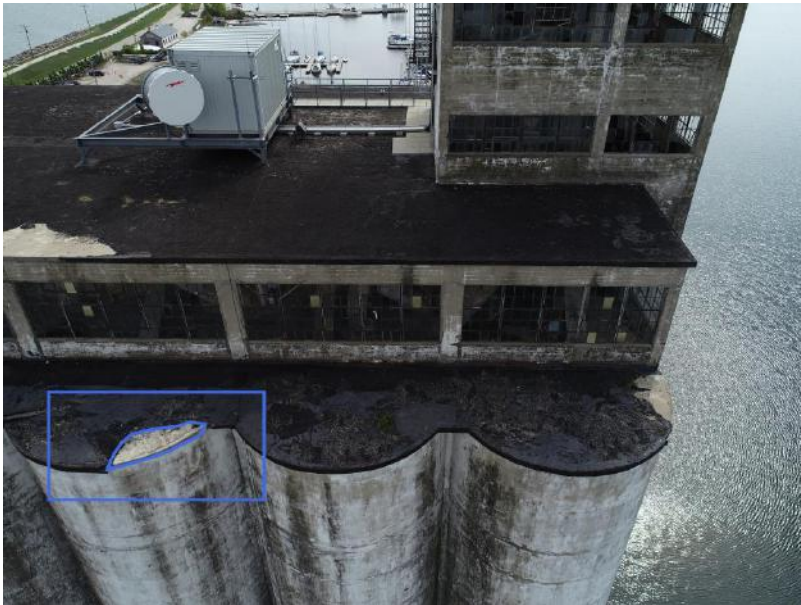
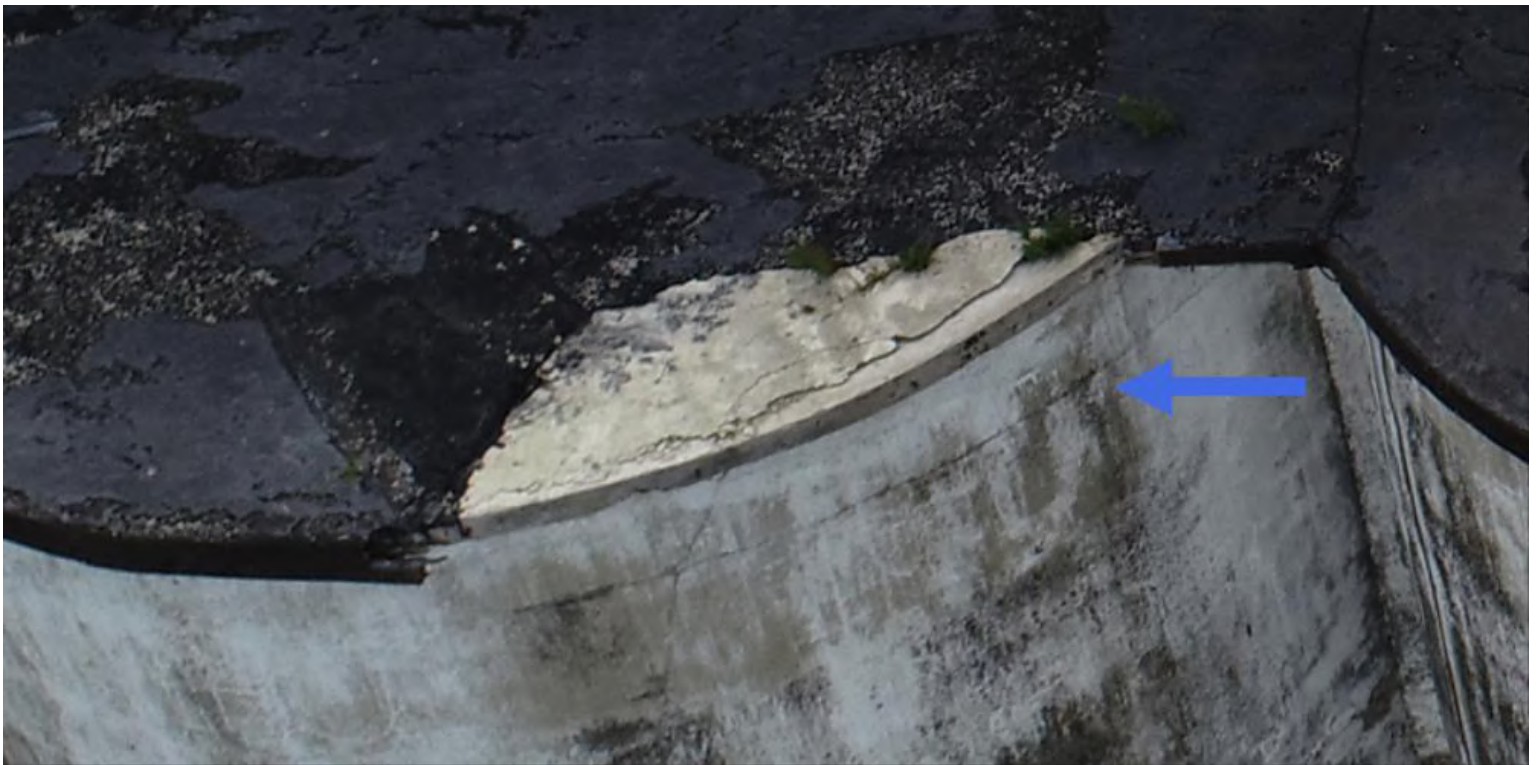
Anomaly No. 7

Type	Flaking
Latitude	44.510446
Longitude	-80.223007
Image	DJI_0011.JPG
Area (sq. m)	1.638916
Status	Request for repair

Critical - Immediate attention required

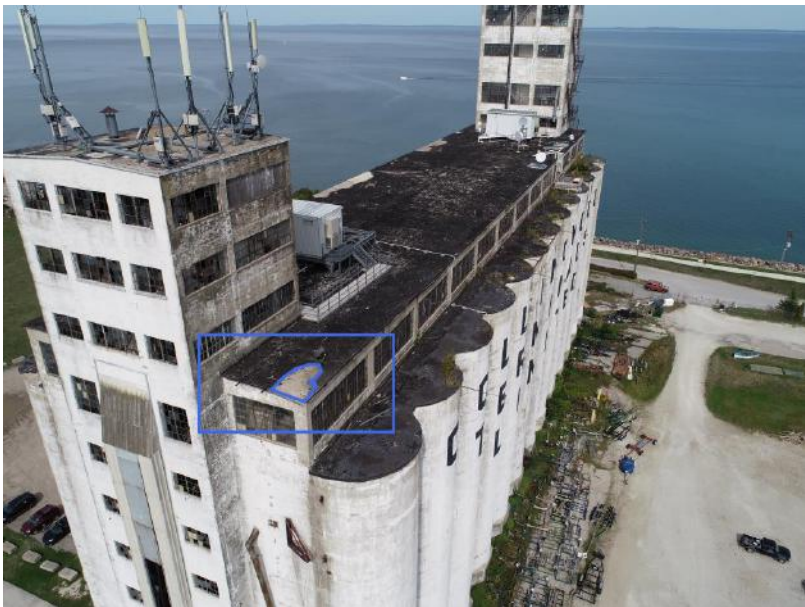
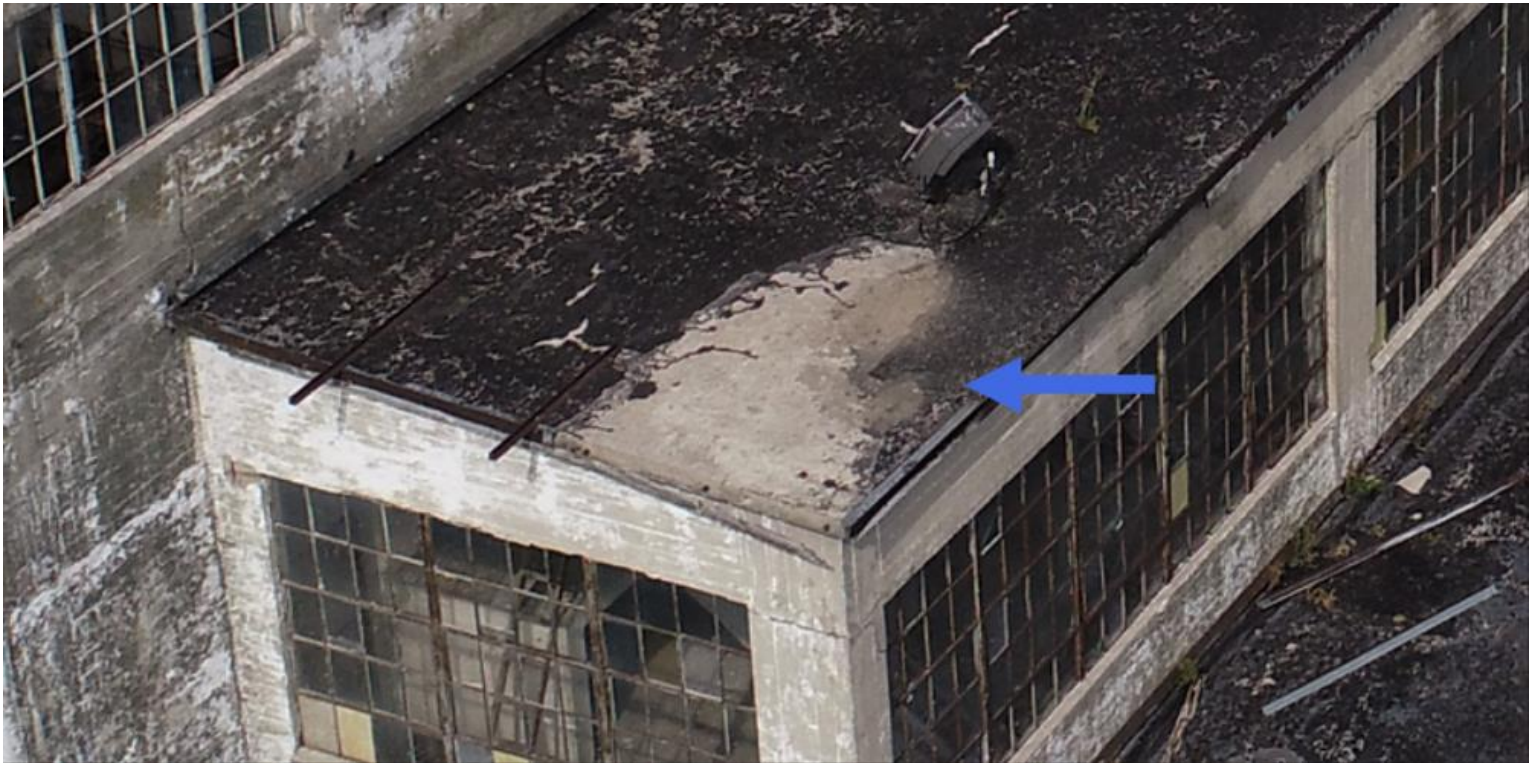
Anomaly No. 8

Type	Flaking
Latitude	44.510205
Longitude	-80.222938
Image	DJI_0603.JPG
Area (sq. m)	2.756348
Status	Request for repair

Critical - Immediate attention required

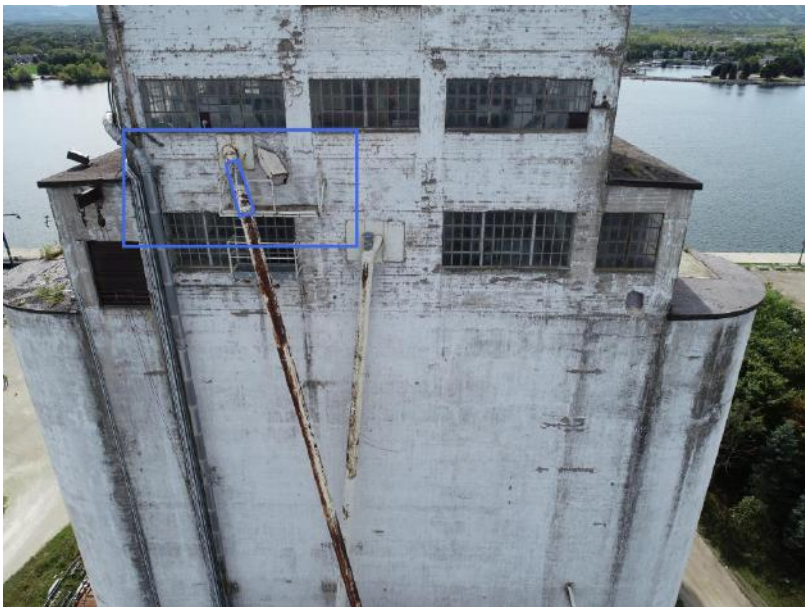
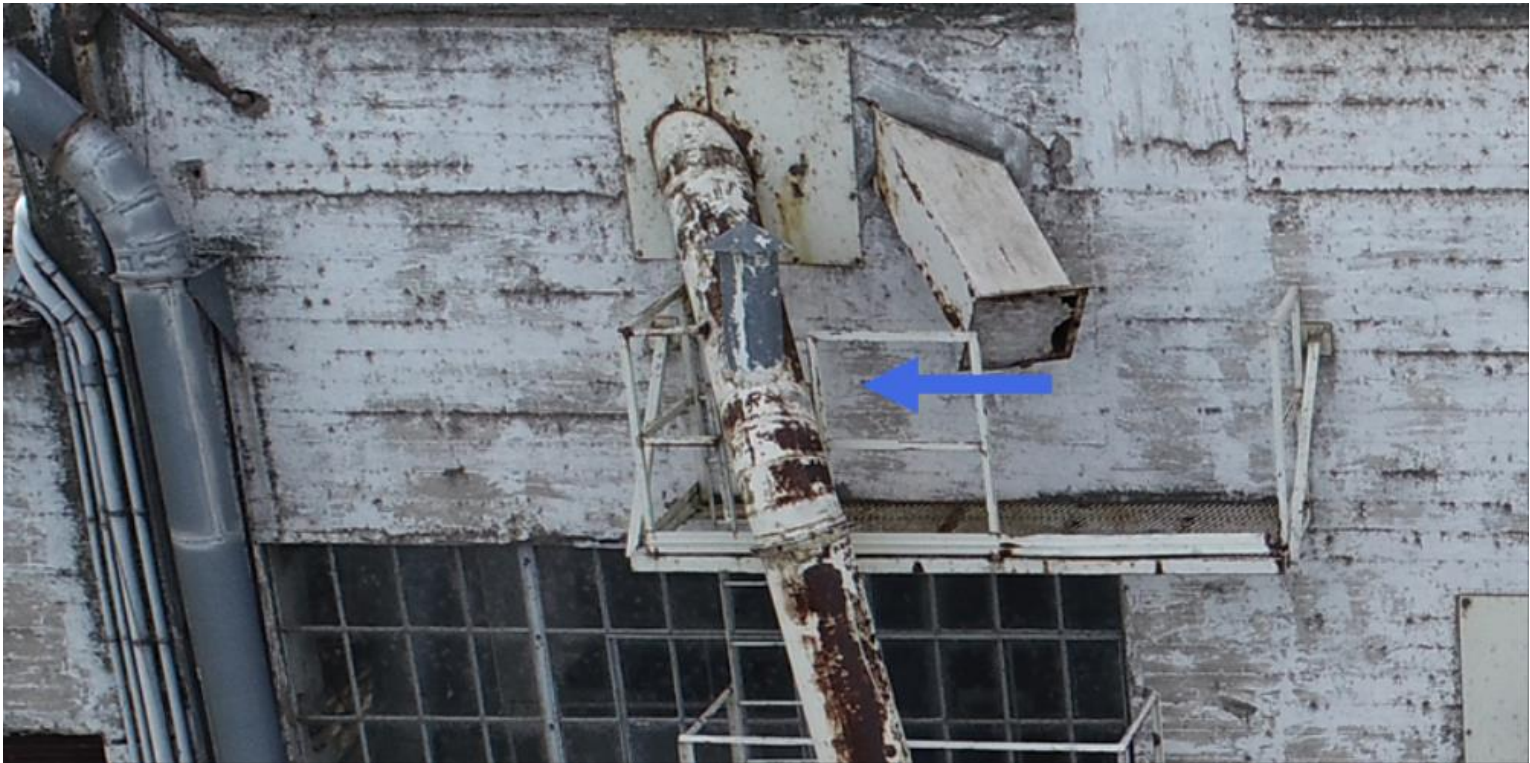
Anomaly No. 9

Type	Flaking
Latitude	44.510835
Longitude	-80.222132
Image	DJI_0757.JPG
Area (sq. m)	0.565186
Status	Request for repair

Critical - Immediate attention required

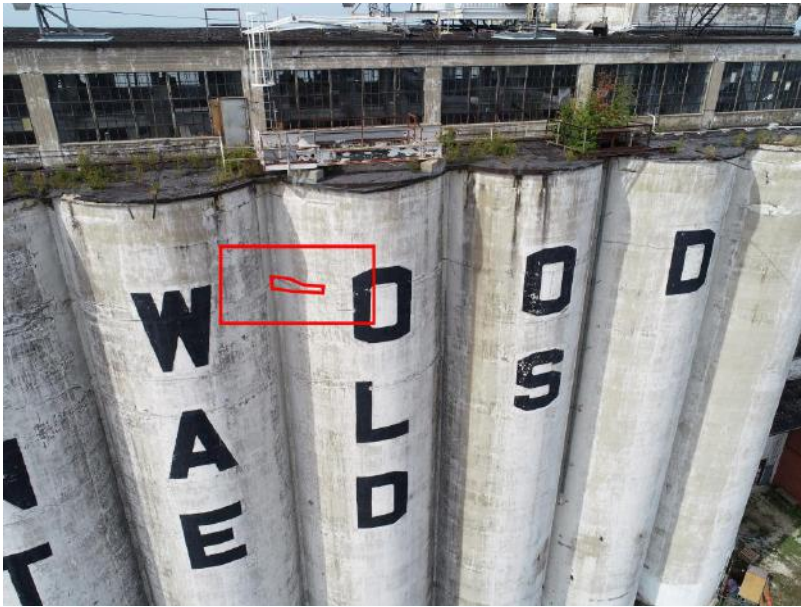
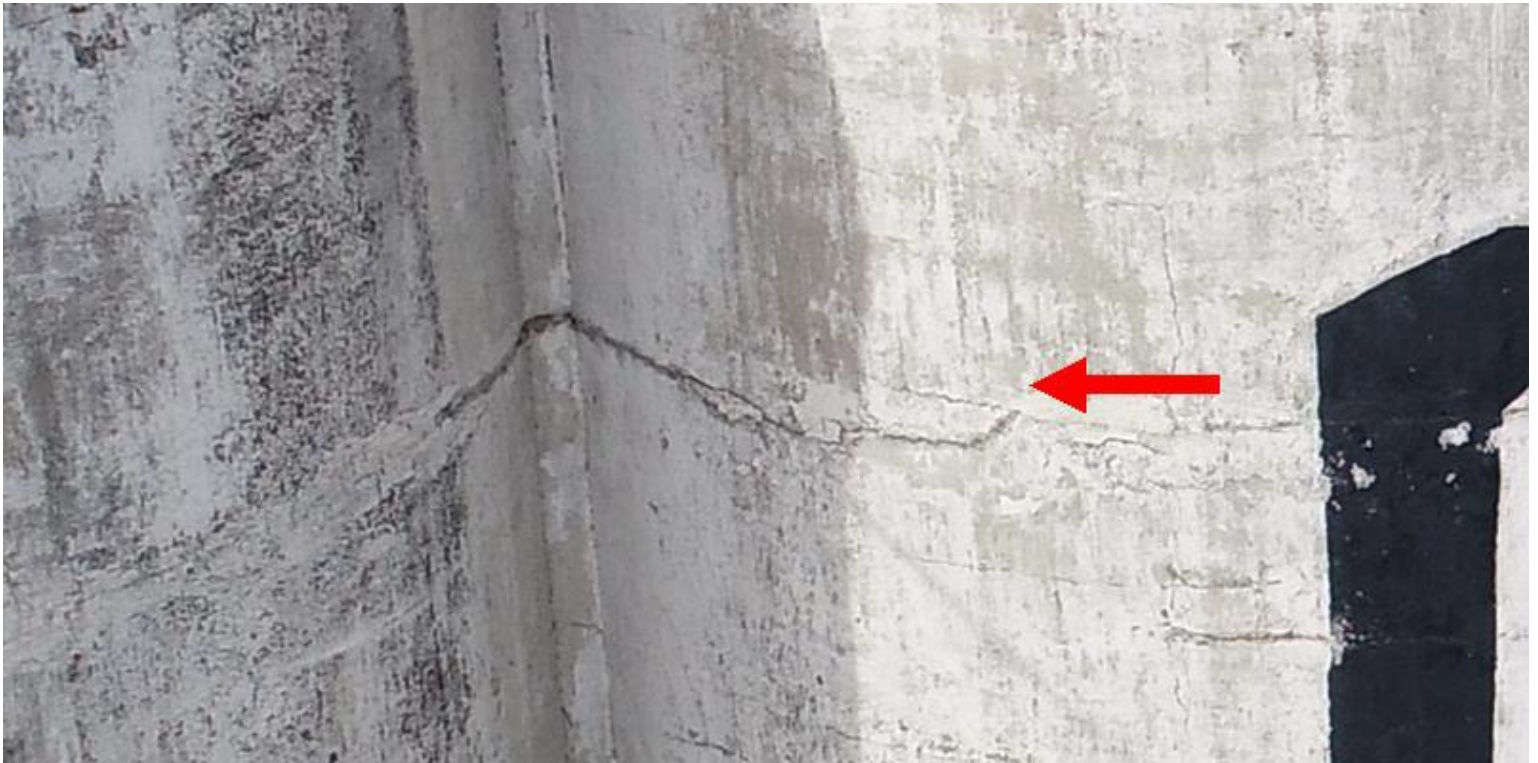
Anomaly No. 10

Type	Hairline Crack
Latitude	44.510590
Longitude	-80.222324
Image	DJI_0673.JPG
Area (sq. m)	0.026855
Status	Request for repair

Not critical but re-exam in 3 years

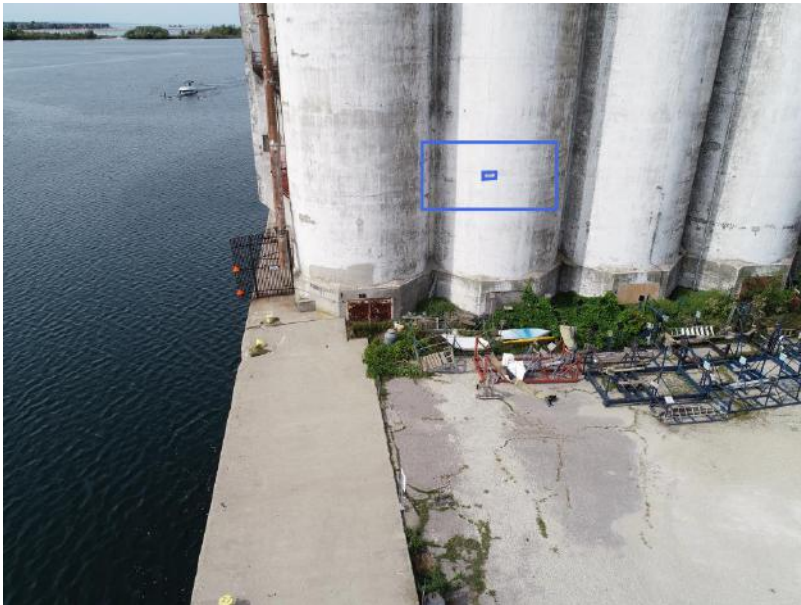
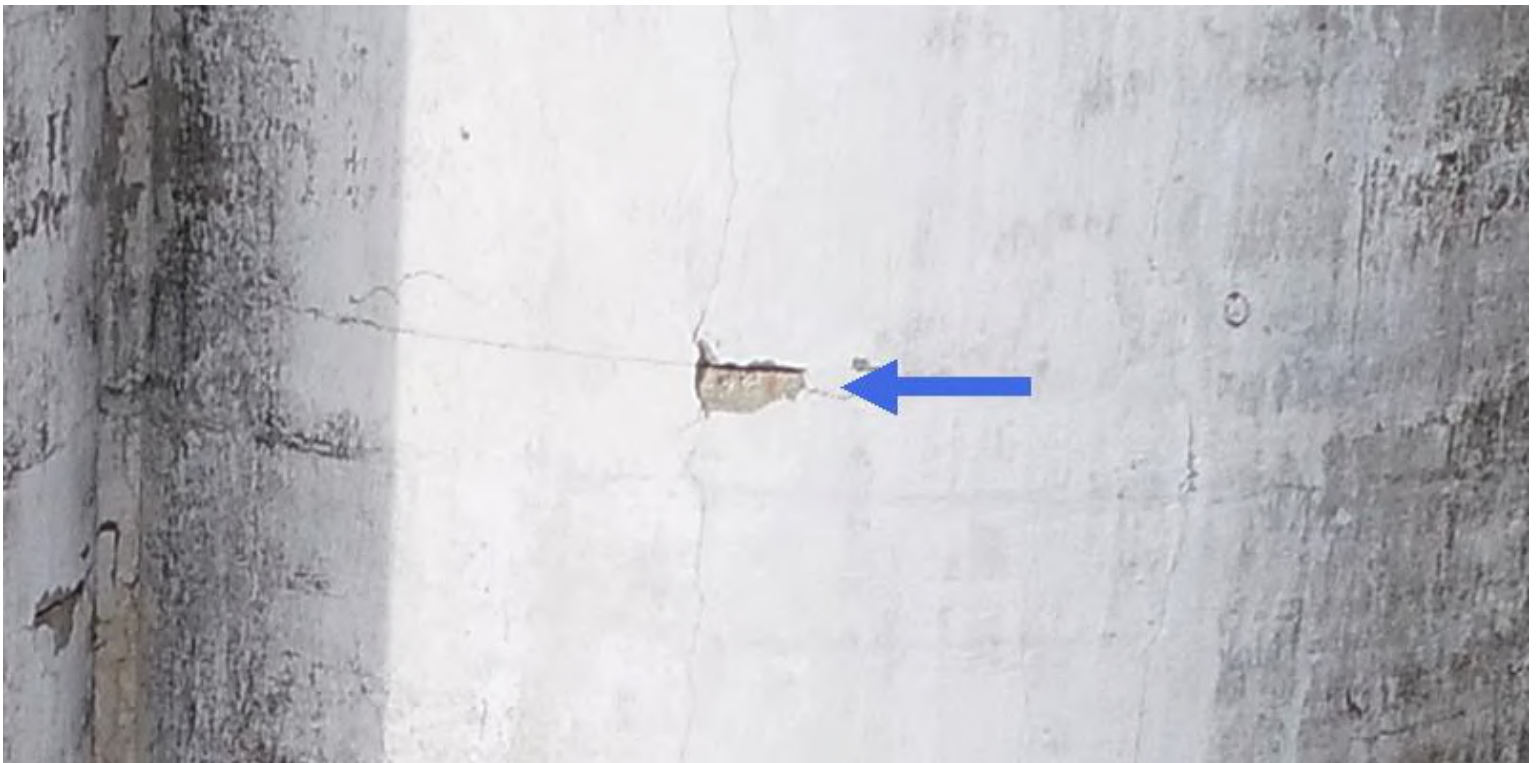
Anomaly No. 11

Type	Flaking
Latitude	44.510228
Longitude	-80.222829
Image	DJI_0655.JPG
Area (sq. m)	0.075439
Status	Re-request for repair

Not critical - re examine in 3 years

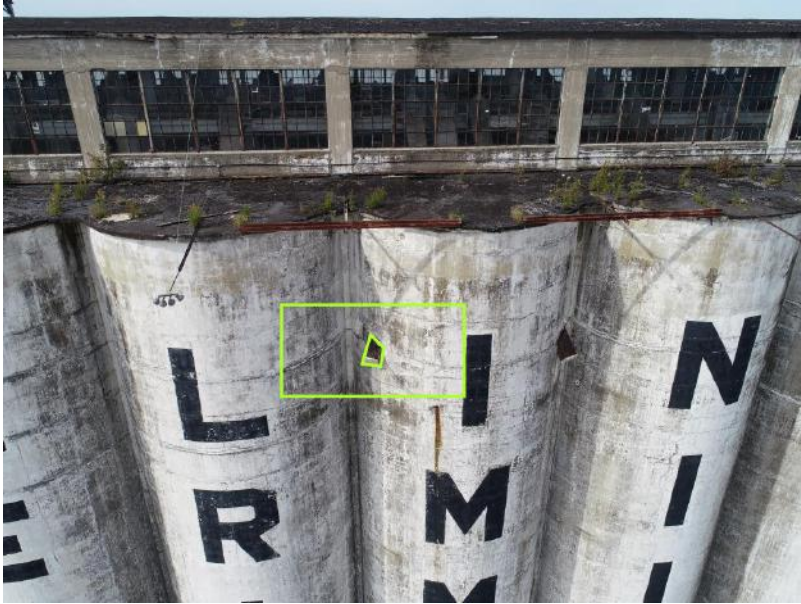
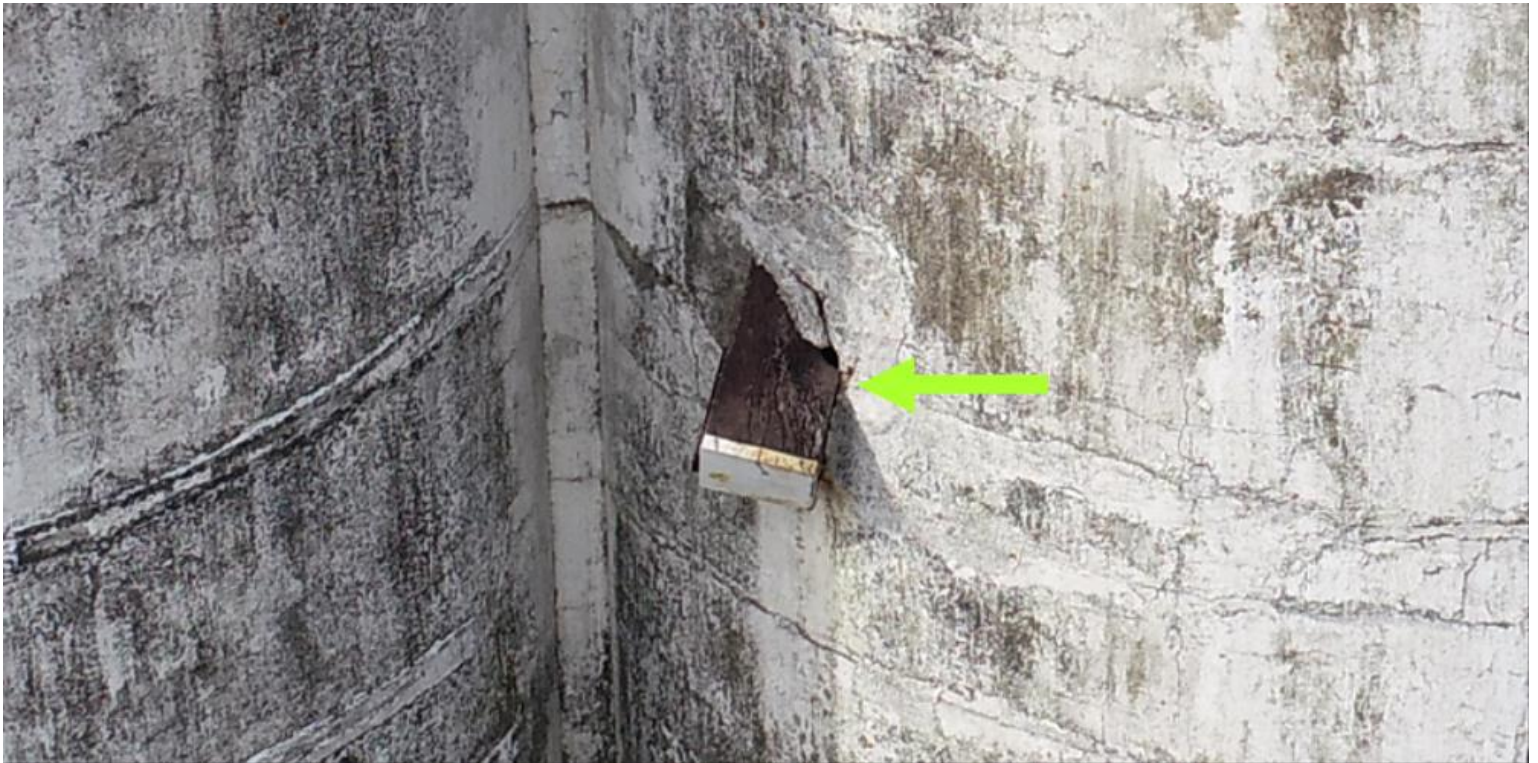
Anomaly No. 12

Type	Others
Latitude	44.510403
Longitude	-80.222580
Image	DJI_0665.JPG
Area (sq. m)	0.103516
Status	Request for repair

Critical - Immediate attention required
